PEDESTRIAN STUDY
For the
US Highway 49 Corridor

Updated December 2021

**The City of Gulfport
4050 Hewes Avenue
Gulfport, MS 39507**

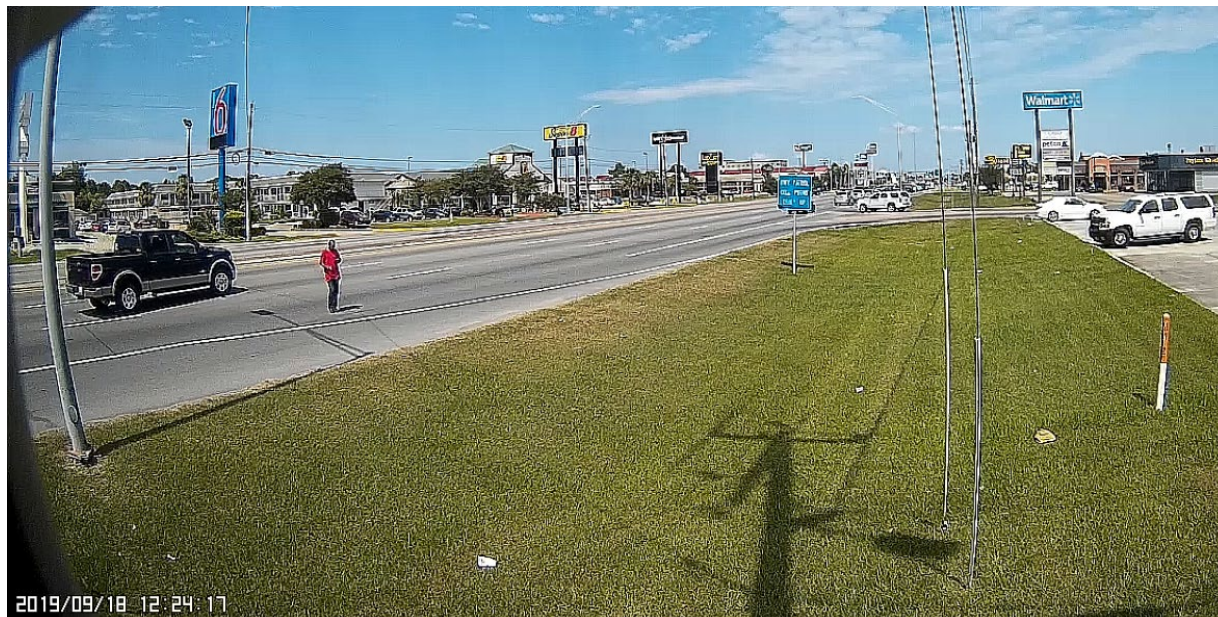
Above: Pedestrian crossing US Highway 49 mid-block, south of Wal-Mart driveway, while looking down at his cell phone, causing the truck to change lanes to avoid him.

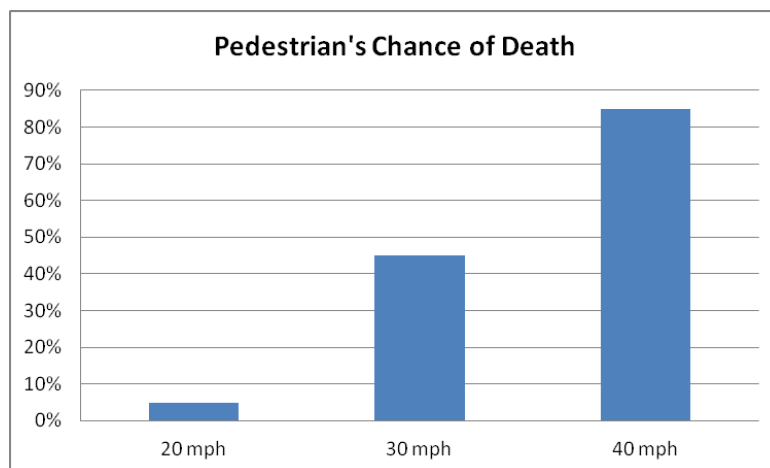
Figure 4 – Fatalities Based on Speed of Vehicle

Location, speed, time of occurrence, and alcohol impairment are major determining factors that contribute to conflicts between pedestrians and vehicles. According to the *National Safety Council*, 65% of crashes involving pedestrians occur at non-intersections (mid-block crossings). Most crashes occur during high traffic volumes such as morning and night; however, more crashes occur between 3:00pm-6:00pm when darkness and alcohol impairment play significant roles. Speed is a major contributing factor in all crash types. At high speeds, motorists are less likely to see a pedestrian or be able to stop in time to avoid a crash, according to the *Pedestrian Safety Guide*. **Figure 4** represents a pedestrian's chances of death if hit by a vehicle, based on the speed of the vehicle striking the pedestrian.

Source: U.K. Department of Transportation

Based on the information provided in Figure 4 and the observed free-flow traffic speeds on US Highway 49, the pedestrian chances of death if struck by a vehicle are in excess of 85% (posted speed is 50 mph). Reducing the posted speed limit to 45 mph would have little impact on capacity, yet would provide some degree of potential for reducing injuries or chance of death to pedestrians in the corridor. Reduction of the posted speed limit to 45 mph is recommended in this section of US Highway 49.

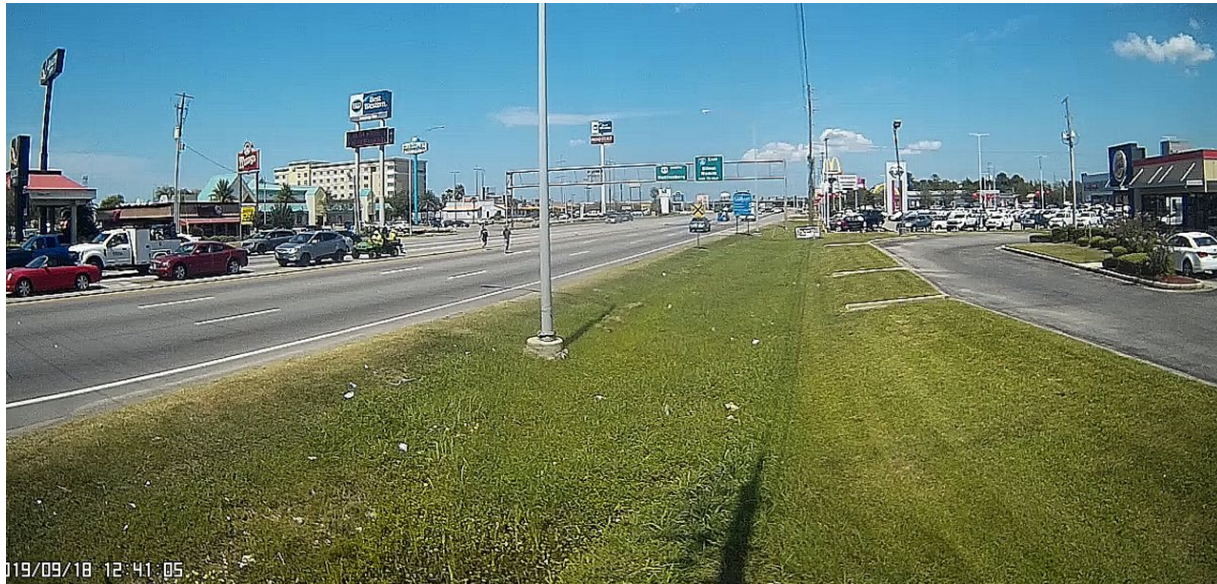
Looking north along US Highway 49 at stormwater detention area and 2 pedestrians crossing.

The width of right-of-way varies in the corridor; however, the section where the majority of the pedestrian incidents have occurred has 210 ft of right-of-way and approximately 108 ft of asphalt. The undeveloped portion of the right-of-way between the adjacent retail property and edge of pavement is primarily used as detention for stormwater. Locating a new sidewalk/multi-use path near the back of the right-of-way would provide a better buffer between thru traffic and pedestrians. Locating a new sidewalk/multi-use path closer to the edge of pavement could possibly get more use and draw more of the pedestrians/bicyclists off US Highway 49 on a new pedestrian/bicycle facility. Drainage impacts will need to be evaluated with the construction of a new sidewalk/multi-use path within the existing right-of-way.

The minimum offset from the edge of travelled way is recommended to be 6 ft to the edge of the proposed multi-use path.

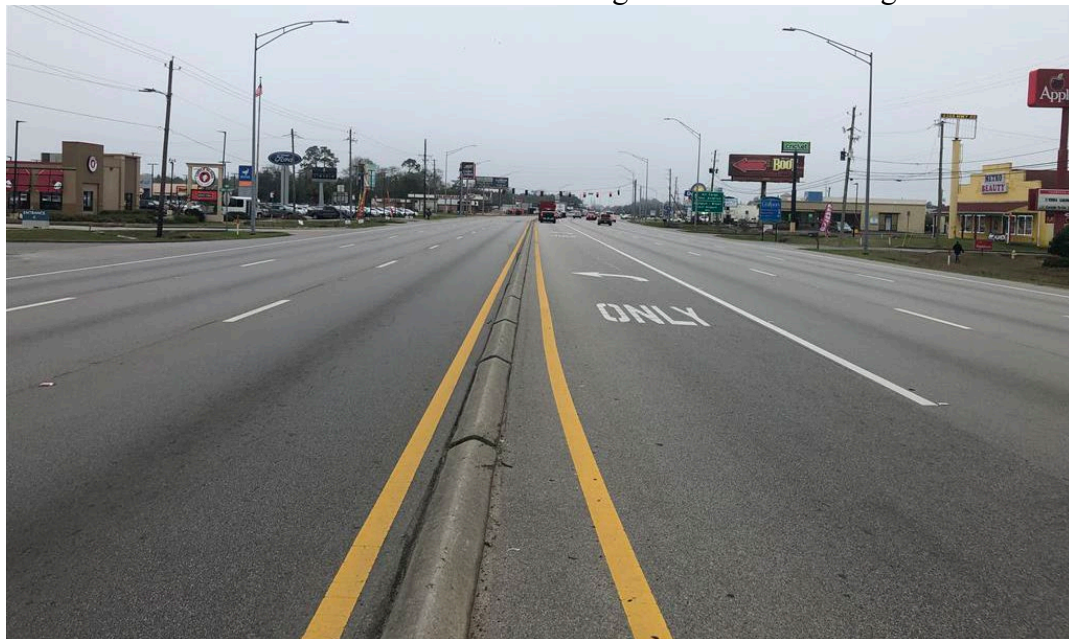
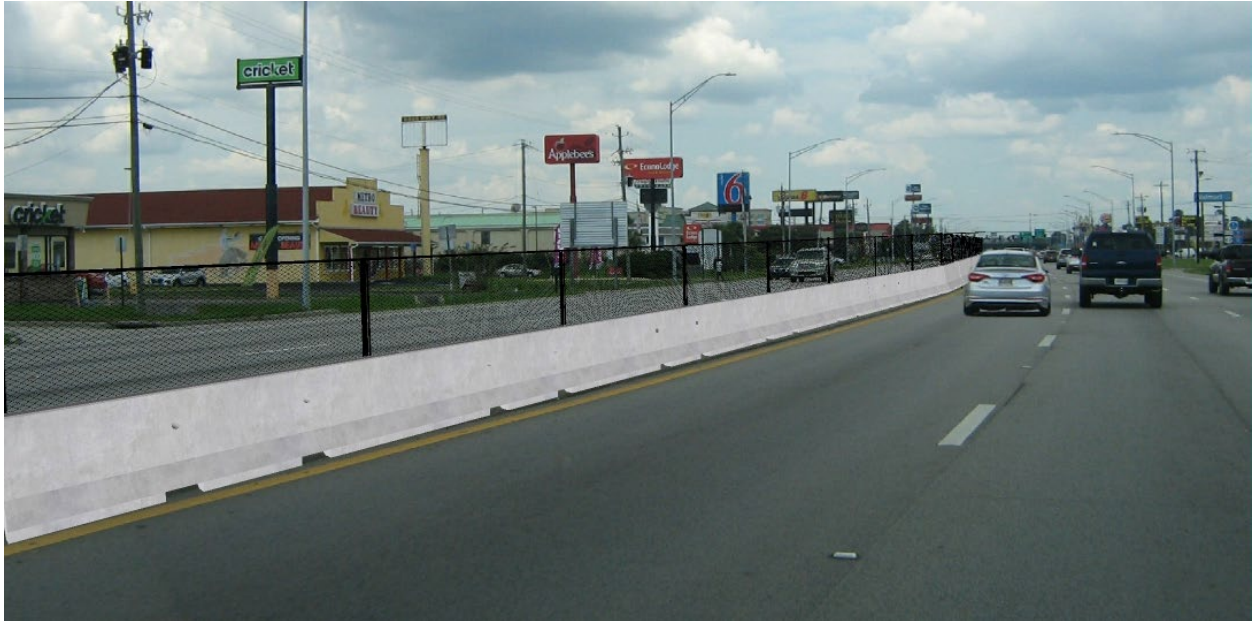
Above: 42” concrete barrier with 42” cyclone fence on top of barrier.

Below: 42” concrete barrier with 42” wrought iron fence on top of barrier.

Design concepts evaluated multiple concepts for median modifications to restrict mid-block pedestrian crossings. The median on US Highway 49 narrows to a 12” slotted curb in many locations along left turn lanes. Installing a jersey barrier/concrete median barrier would be an obstacle that could ramp up from a low profile (to avoid being a fixed object in the clear zone that would require attenuators at each end). The standard barrier height ranges from 32”-42” and is 2 ft in width. This concept could be easily traversed by pedestrians. However, the addition of a fence above the barrier could further discourage mid-block crossings.

The median barrier/fencing is recommended to extend from the south side of the railroad crossing right-of-way on US Highway 49 (just north of Creosote Road) south to Fisher Boulevard, just south of Airport Road – a distance of approximately 3,700 ft.

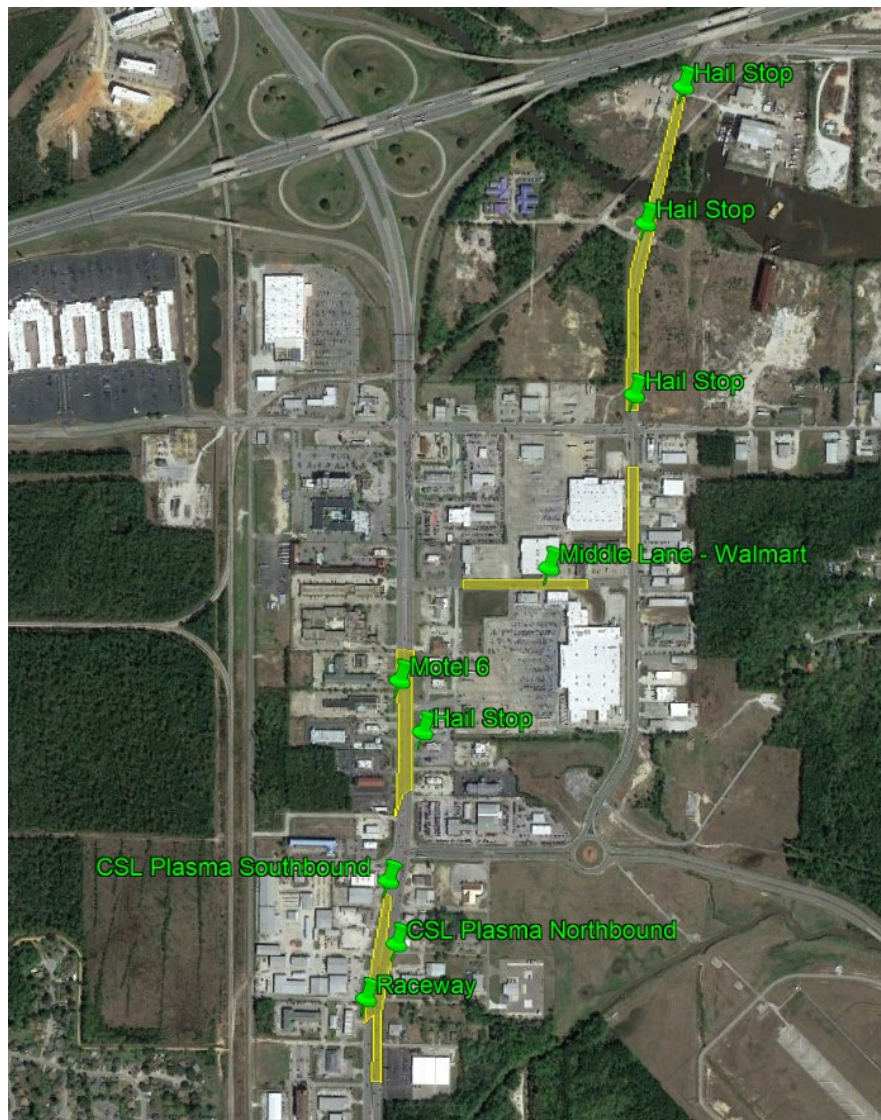
CTA Bus Stops/Hail Stops, Source: CTA, 2020.

The CTA public transportation operates bus routes in the study area with both set bus stops and with “Hail Stop” locations where they will pick up passengers (in shaded areas on graphic below) when requested in safe locations. The graphic shows that Three Rivers Road has multiple Hail Stop locations, a fixed stop at Walmart, Motel 6 on US Highway 49, CSL Plasma (north and south), and Raceway. Much of US Highway 49 between Motel 6 and Russell Blvd is a Hail Stop location for CTA.
