BEATLINE ROAD

TRAFFIC SAFETY OPERATIONS STUDY

September 2009

Final Report

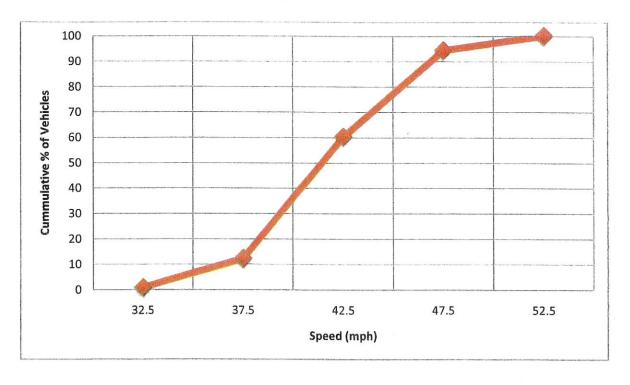
The spot speed study results show the 50th percentile or median speed along Beatline Rd. between Red Creek Rd. and 28th St. is 41.6 mph and the 85th percentile speed is 46.1 mph. The pace speed was determined to be between 38 mph and 47 mph. At least 35 % of the vehicles tested were in compliance with the posted speed limit. To increase the number of vehicles traveling at the posted speed limit, strict enforcement of the posted speed limit is recommended. A sample size of 123 random vehicles was recorded. Complete results from the spot speed study are provided in **Appendix A**. **Figure 1** shows the distribution of vehicle speeds recorded during the spot speed study.

A spot speed study was conducted using radar to obtain an accurate distribution of speeds through the study area. Vehicle spot speed data was collected at a central location along Beatline Rd. between Red Creek Rd. and 28th St. for both northbound and southbound traffic on Tuesday September 15, 2009 from 12:30 PM to 1:30 PM using a handheld directional radar gun. The posted speed limit on Beatline Rd. is currently 40 mph.
